Project *Woodlands – Root Barrier Installation*

Client *Uttlesford District Council*

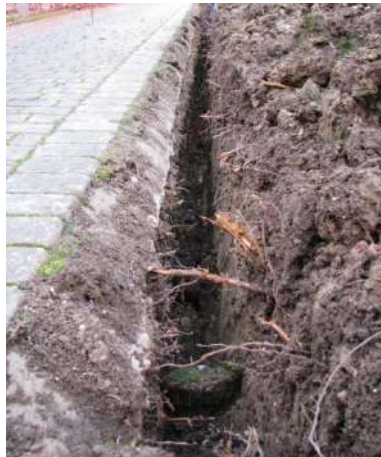
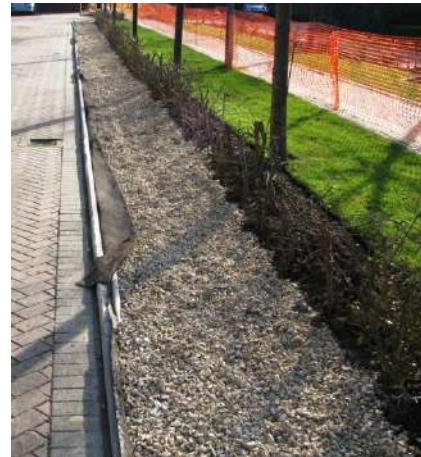
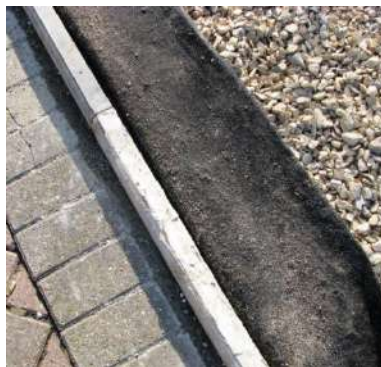
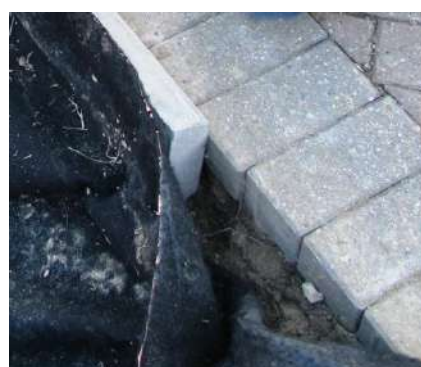
The Problem: Uttlesford adopted the infrastructure landscape and highways to a large housing development. Lime trees had been planted to create an avenue to frame a public foot path that runs through the site. A number of home owners saw that the limes were undermining the block pave of their shared driveway and wanted Uttlesford to take action to resolve this problem. The home owners were also concerned about the potential damage that trees may cause to their drive and homes.

PBA's Role PBA initially completed a visual survey to investigate the driveway damage to ascertain if this can be contributed to tree roots. The survey confirmed that roots were in contact with the block pave and where thought to be exploiting the damp sandy conditions found in the construction layer of the drive. Recommendations were made to deal with the situation to prevent root proliferation within the block pave sand layer which given time could cause lasting damage to the drive.

PBA supplied and supervised the installation of a permeable cooper root barrier. This specialist dual action barrier stops roots in two ways. The first is through the perforated cooper layer which signals to roots not to grow. The second way that the barrier works is to physically stop the barrier from growing. In essence the barrier is designed to provide a barrier to roots in the long term through having a design life in excess of 50 years
